**BOEING AEROSPACE AND ELECTRONICS PLANT 2
SEATTLE, WASHINGTON**

**PRELIMINARY ASSESSMENT REPORT
RCRA FACILITY ASSESSMENT**

Work Assignment No.	: R10018
EPA Region	: 10
Date Prepared	: January 7, 1992
Contract No.	: 068-W9-0009
Site No.	: WAD009256819
Prepared by	: PRC Environmental Management, Inc.
PRC Project Manager	: Kit Walther
Telephone	: 206/624-2692
EPA Work Assignment Manager	: Marcia Bailey
Telephone	: 206/553-0684

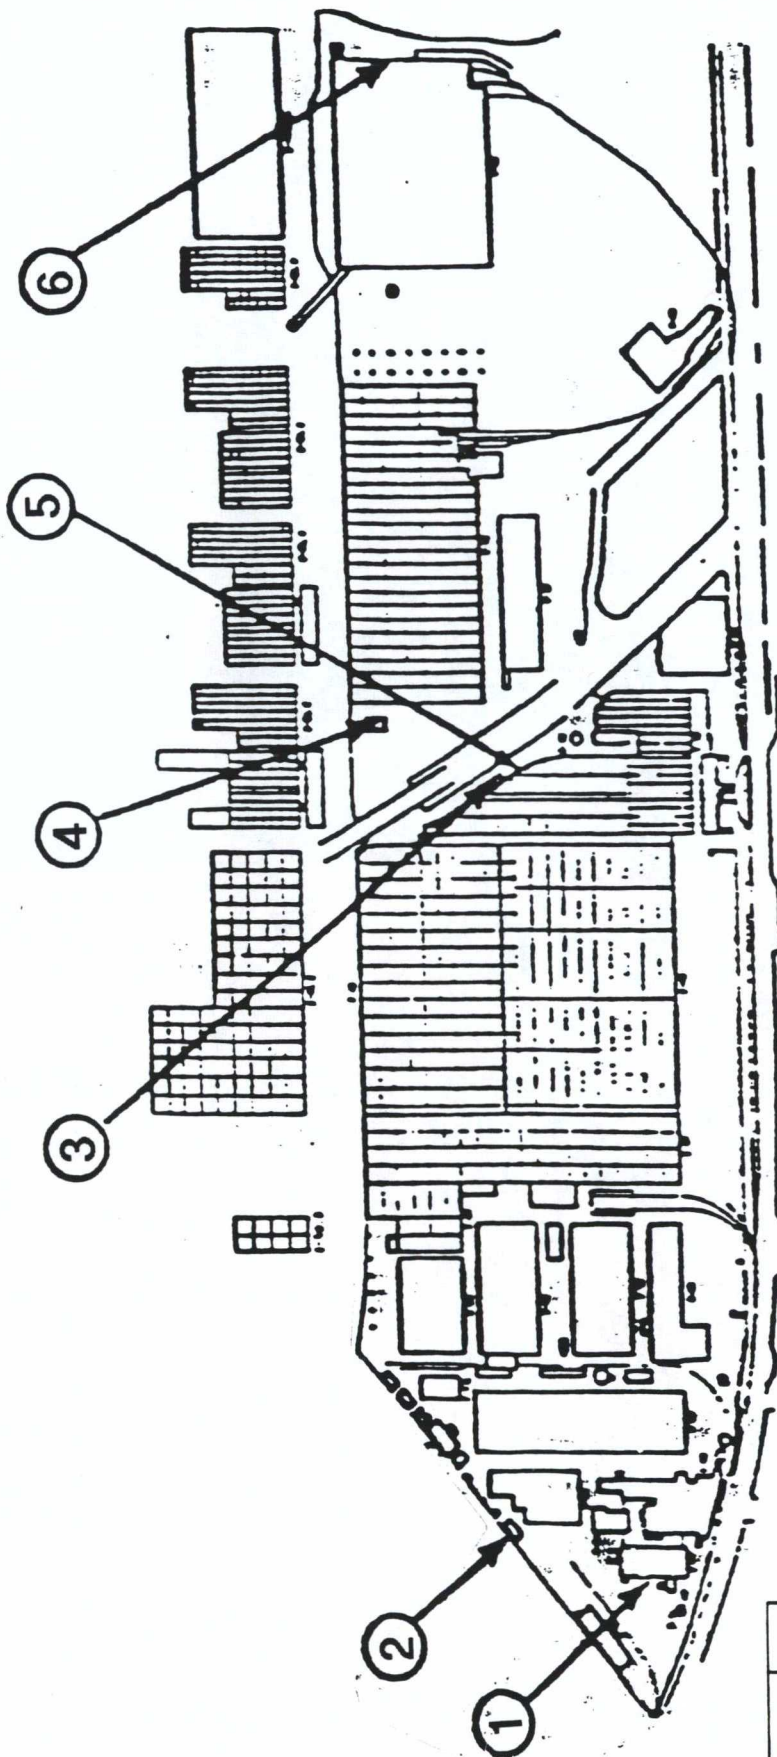
Figure 4
Central Hazardous Waste
Staging Areas

The six central hazardous waste staging areas (Figure 4) are considered by Boeing as the only RCRA regulated areas under interim status (Fujita, 1990).

Central hazardous waste staging area number 1 (2-104 building) consists of a shed to store drums of waste prior to shipment for disposal (Figure 4). Normally, the drums are stored in this area for less than 30 days. Four types of hazardous wastes are stored in separate compartments. Each compartment has a separate 170-gallon containment trench. The containment holds 10 percent of the maximum quantity that may be stored in the area. The drums are bound together and stacked two high on pallets using a forklift equipped with a barrel clamp. Maximum capacity for each compartment is 48 drums.

A shed holds tanks of oily liquid waste and free oil in the central hazardous waste staging area number 2 (2-91 building) (Figure 4). Two fixed steel storage tanks with volumes of 2,500 and 1,000 gallons and two portable 500-gallon tanks are housed at this location. Wastes are transported from the place of generation by mobil tankers to the 2-91 building. Lubricating coolants are pumped to the larger storage tanks for later transfer to the disposal contractor's tanker truck. The tanks are constructed of 1/4-inch steel plate. Waste oils are pumped to the two 500-gallon portable tanks for later transfer to an oil-recycling contractor's tanker truck. A coolant separator located in the 2-91 building is no longer active. This system was used to separate oil and water and discharge the water to the Metro sewer. The drain line to the Metro sewer was disconnected in 1975. The tanks are located in a sloped and curbed area to contain any spillage that might occur. The spill collection sump has a capacity of 3,100 gallons.

Central hazardous waste staging area number 3 contains a 6,000-gallon tank (Figure 4); however, the waste-holding capacity is limited to 5,000 gallons. The tank is made of 1/4-inch steel and lined with 1/8-inch thick PVC to contain waste acids from manufacturing processes. There are no automatic level controls on this tank, and the waste handler is responsible for keeping the tank contents below the maximum fill level. A 5,000-gallon retention basin is located below the holding tank. The sump is checked on a daily basis for evidence of tank leaks. Accumulated rainwater that drains to the retention basin from the diked truck-loading area is periodically pumped into the holding tank.

Central hazardous waste staging area number 4 contains a 4,000-gallon tank for holding concentrated chrome waste from chrome-bearing rinse waters. The tank is made of chromic acid-resistant fiberglass approximately 3/16 inch thick (Figure 4). The tank is located inside of the 2-09 building and receives chromic acid wastes that have been concentrated by an evaporator. The wastes are generated by ion exchanges used to purify contaminated rinse waters received from the anodizing process line adjacent to the 2-10 building and wastewater received from a small anodizing operation located in the 2-62 building. Any leaks or spills flow to a waste holding sump located in the 2-10 building. This sump also provides spill retention for the process line.

Central hazardous waste staging area number 5 consists of a 1,000-gallon sump within the cleaning facility for aircraft landing gears (Figure 4). Solvents used in the cleaning operations drain onto a sloped floor, which has a grating, and into the sump. When personnel observe that the sump is full, solvent is pumped to the oil/solvent disposal contractor's tanker truck.

Central hazardous waste staging area number 6 is used for holding spent plating solutions and used laboratory wastes containing cyanide (Figure 4). The cyanide waste is stored and transported by a disposal contractor in 375-gallon containers approved by the U.S. Department of Transportation (DOT). A maximum of four containers are stored in this area at one time. The containers are stored in a covered shed on a grating directly over a 1,500-gallon spill retention basin. This area is also used as a holding area for semisolid cyanide wastes generated on-site. These wastes are subsequently transported to staging area number 1 for pickup by the disposal contractor. The area also stores small containers of liquid cyanide generated by on-site laboratories. These containers, which contain up to 5 gallons, are transferred to the DOT containers prior to disposal (Vigna, 1986).
